**Sampling Plan for Event 1B  
for the Commencement Bay Nearshore/Tideflats Superfund Site -  
Hylebos Waterway Problem Areas**

**Final Report**

July 7, 1994

Striplin Environmental Associates, Inc.

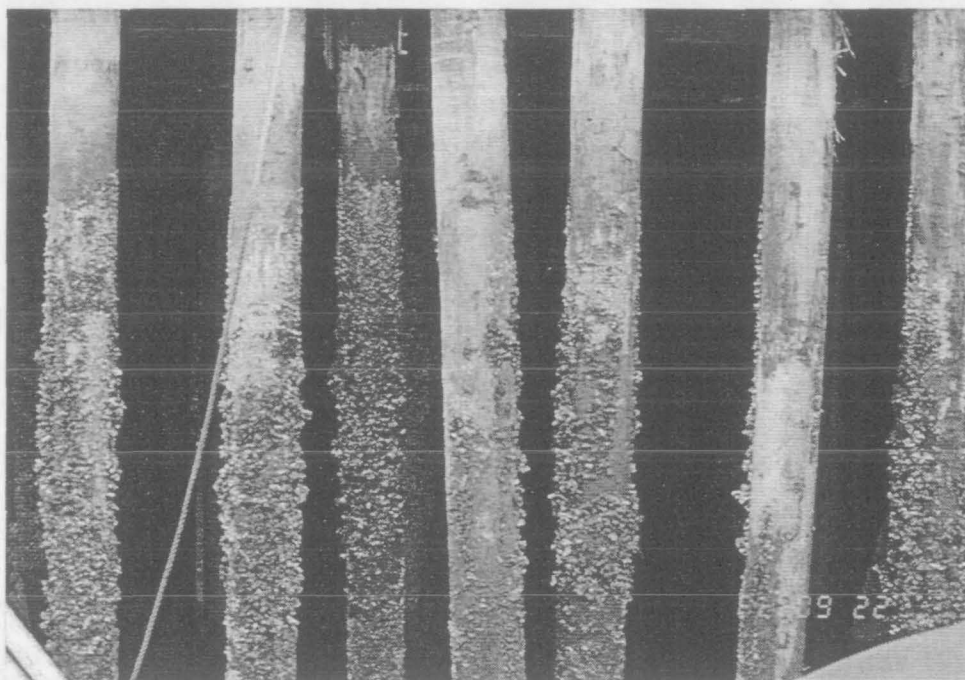
## **Sample Area 5201I (West end of pier) AK-WA Shipbuilding Plate 1**

Photo was taken at an estimated tidal height of -0.7 foot

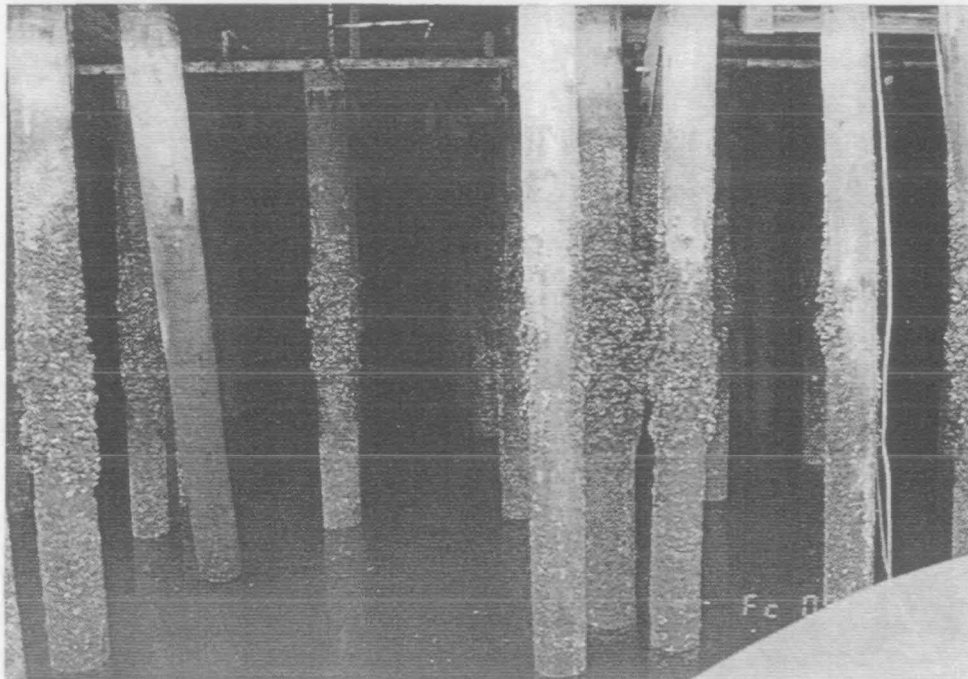
Sample Area 5203I (East end of pier) Port Industrial Yard Plate 3

Photo was taken at an estimated tidal height of -0.8 foot

Sampling area 5203I is under the eastern end of the pier adjacent to the Port of Tacoma Industrial Yard. The composite length is approximately 800 feet. There are ten outfall pipes listed on the TPCHD map for the sampling area (TPCHD No. 87-89). The bank in the sample composite area is under the pier and not visible from the waterway. Based on available studies, problem chemicals suspected to be associated with this site include: copper, lead, and zinc (Ecology 1992). Past industrial activities adjacent to the sampling area include shipbuilding and dismantling by Todd Shipyards, the U.S. Navy, and the Zidell Dismantling Corporation.

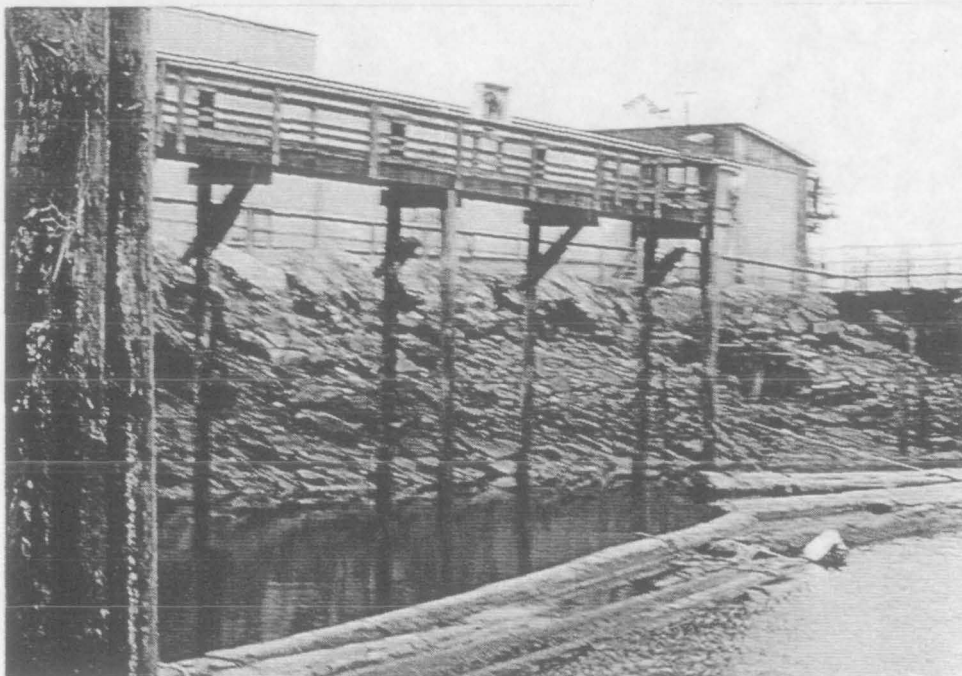
Photo was taken at an estimated tidal height of -1.0 foot

Sample area 5205I is located at the toe of the bank and extends for about 200 feet eastward. There are three drains on the bank listed on the TPCHD map (No. 85 and 86). Occidental Chemical Corporation currently has an Individual NPDES permit for the discharge of wastewater and stormwater. The bank consists of small rocks on the slope and a coarse-grained, sand-like material at the toe of the bank. This is the area identified in Ecology's Milestone 2 report where groundwater may surface and seep into the waterway. Based on available studies, problem chemicals which are suspected to be associated with this site include: trichloroethane, 1,2-dichloroethylene, tetrachloroethane, hexachlorobenzene, and hexachlorobutadiene and various metals including copper, chromium, cadmium, lead, and zinc (Ecology 1992, Ecology 1993a).

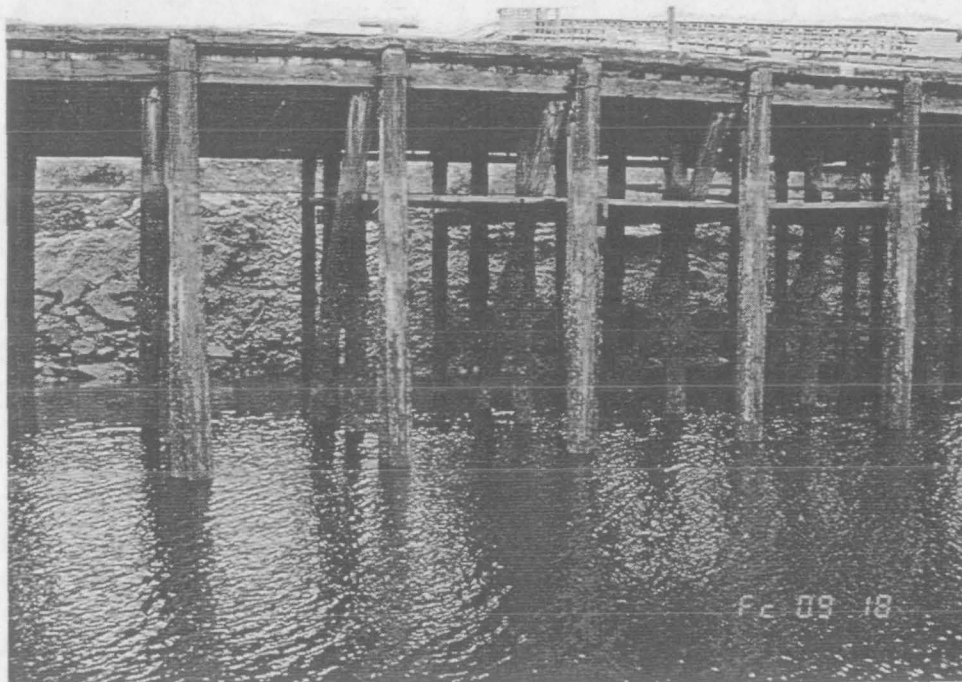
Photo was taken at an estimated tidal height of -1.1 feet

The sampling area is behind the western portion of Occidental Chemical No. 1 dock. The length of the composite segment is approximately 150 feet. There is one drain mapped just to the west of the sampling location (TPCHD No. 85). Occidental Chemical Corporation currently has an Individual NPDES permit for the discharge of wastewater and stormwater. In part, the bank consists of anthropogenic material of unknown origin. Based on available studies, problem chemicals suspected to be associated with this site include: trichloroethane, 1,2-dichloroethylene, tetrachloroethane, hexachlorobenzene, hexachlorobutadiene and various metals including copper, chromium, cadmium, lead, and zinc (Ecology 1992, Ecology 1993a). The facility at Occidental Chemical Corporation was previously operated by the Hooker Chemical Corporation.

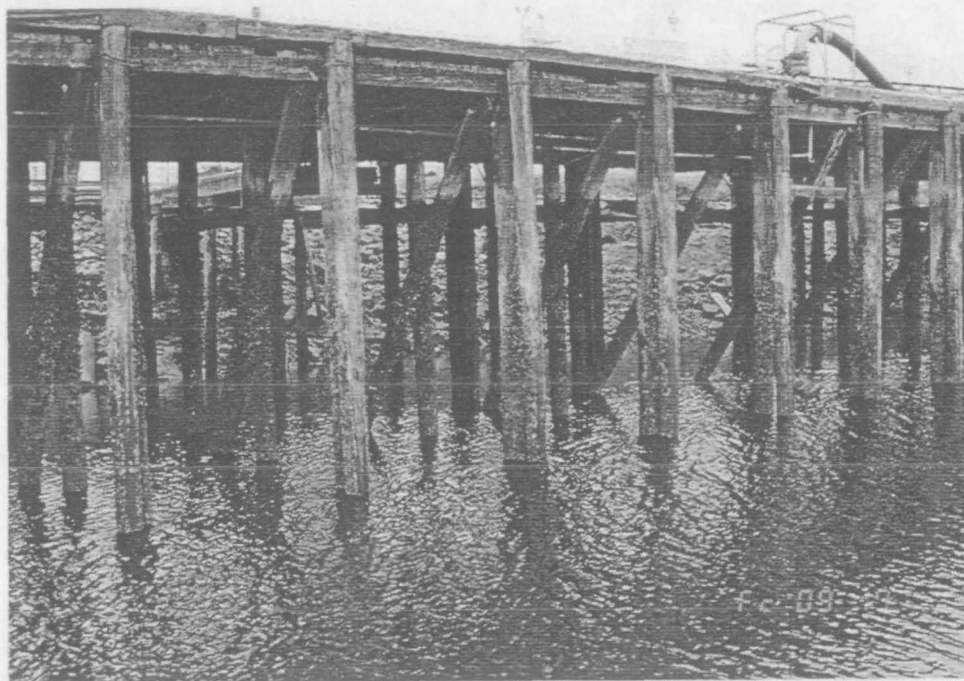
Photo was taken at an estimated tidal height of -1.1 feet

The sampling area is at the eastern end of Occidental Chemical's No. 1 dock. The length of the composite sample is approximately 100 feet. There are two outfall pipes in or adjacent to the composite area listed on the TPCHD map [No. 766, 84 (not in use)]. Occidental Chemical Corporation currently has an Individual NPDES permit for the discharge of wastewater and stormwater. The bank consists of small rocks on the slope with fine-grained, sand-like material at the toe of the bank. Also noted on the toe of the bank was reddish material of unknown characteristics. Based on available studies, problem chemicals suspected to be associated with this site include: trichloroethane, 1,2-dichloroethylene, tetrachloroethane, hexachlorobenzene, hexachlorobutadiene and various metals including copper, chromium, cadmium, lead, and zinc (Ecology 1992, Ecology 1993a). The facility at Occidental Chemical Corporation was previously operated by the Hooker Chemical Corporation.

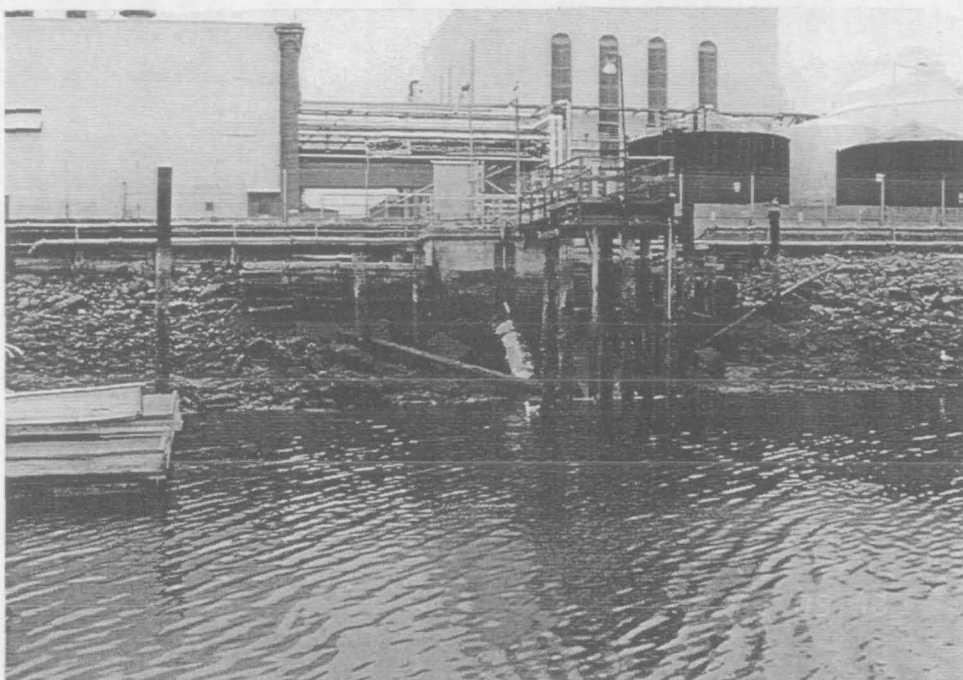
Photo was taken at an estimated tidal height of -1.2 feet

The sample area is in the middle portion of the Occidental facility between Occidental Chemical No. 2 dock and the eastern edge of dock No. 1. It includes the bank area inshore of the main Occidental outfall (TPCHD No. 707). Occidental Chemical Corporation currently has an Individual NPDES permit for the discharge of wastewater and stormwater. The sample composite area is approximately 245 feet in length. The bank consists of large rip rap and the sample will be composited from fine to coarse sand at the toe of the rip rap. Based on available studies, problem chemicals suspected to be associated with this site include: trichloroethane, 1,2-dichloroethylene, tetrachloroethane, hexachlorobenzene, hexachlorobutadiene and various metals including copper, chromium, cadmium, lead, and zinc (Ecology 1992, Ecology 1993a). The facility at Occidental Chemical Corporation was previously operated by the Hooker Chemical Corporation.

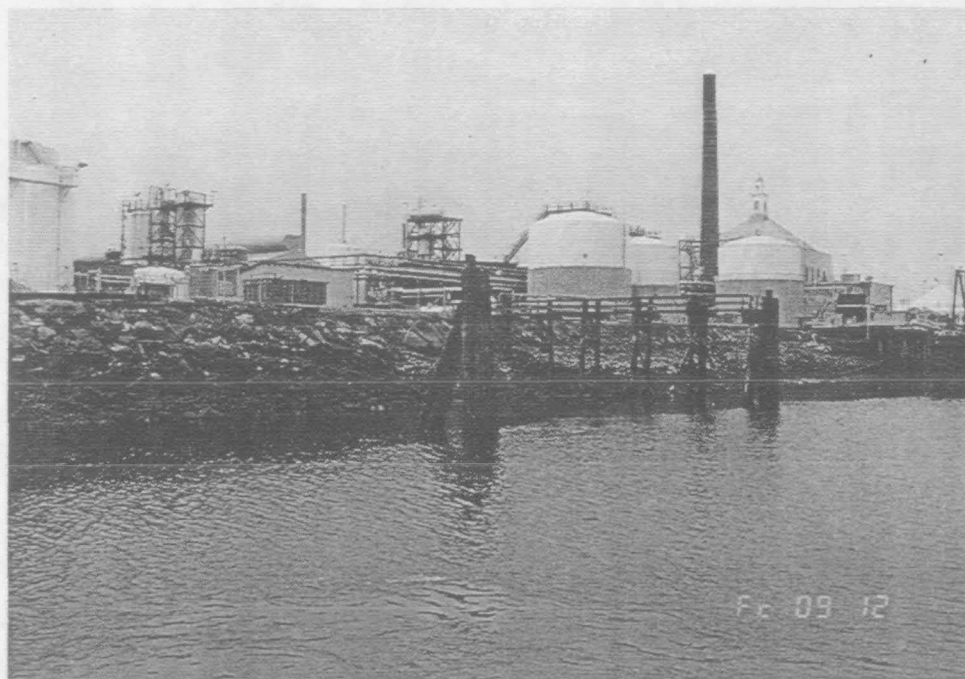
Photo was taken at an estimated tidal height of -1.4 feet

The sampling area is at the east end of the Occidental property. The length of the composite area extends for approximately 650 feet. There are six outfall pipes in the composite area listed on the TPCHD map [No. 83 (not in use)]. Occidental Chemical Corporation currently has an Individual NPDES permit for the discharge of wastewater and stormwater. The upslope portion of the bank consists of rip rap with finer sediment at the toe of the slope. Based on available studies, problem chemicals suspected to be associated with this site include: trichloroethane, 1,2-dichloroethylene, tetrachloroethane, hexachlorobenzene, hexachlorobutadiene and various metals including copper, chromium, cadmium, lead, and zinc (Ecology 1992a, Ecology 1993a). The facility at Occidental Chemical Corporation was previously operated by the Hooker Chemical Corporation.

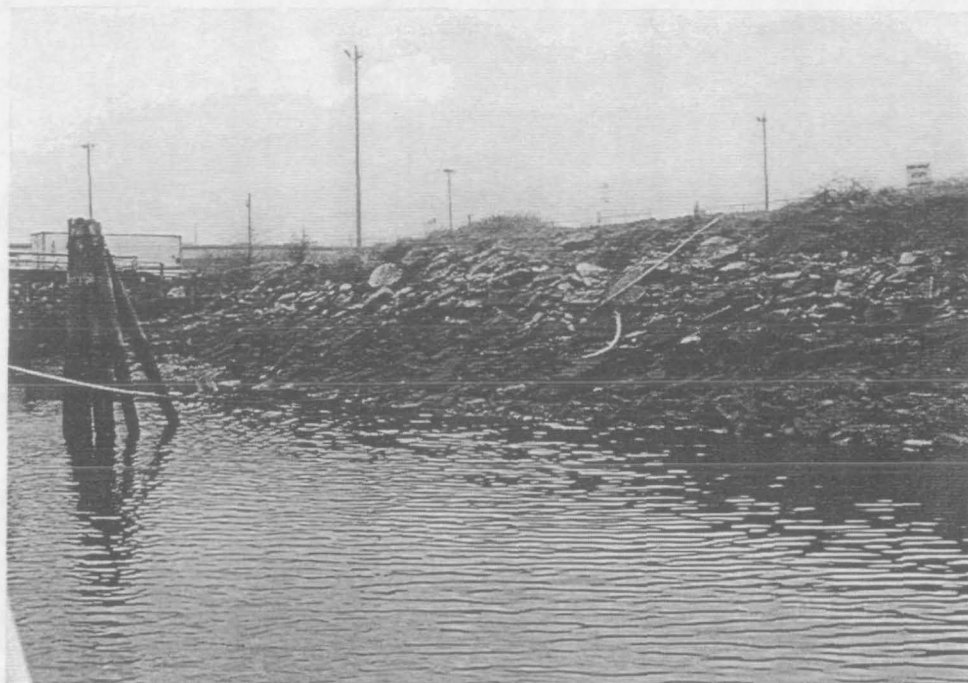
Photo was taken at an estimated tidal height of -1.4 feet

The sampling area extends across the entire shoreline of the property. The length of the composite area is approximately 175 feet. The bank and shoreline are covered with concrete and asphalt blocks and other debris. Carbon electrodes were found on the east end of the bank by Ecology (Mercuri 1994). Ecology sampled the bank sediment in 1992 and found copper, lead, perchloroethylene, trichloroethylene, and dichloroethylene (Coleman 1992a, 1992b). Past industrial practices at the site include seafood processing by Alaska Seafood Co. and petroleum storage by the Fletcher and United Independent Oil Companies.

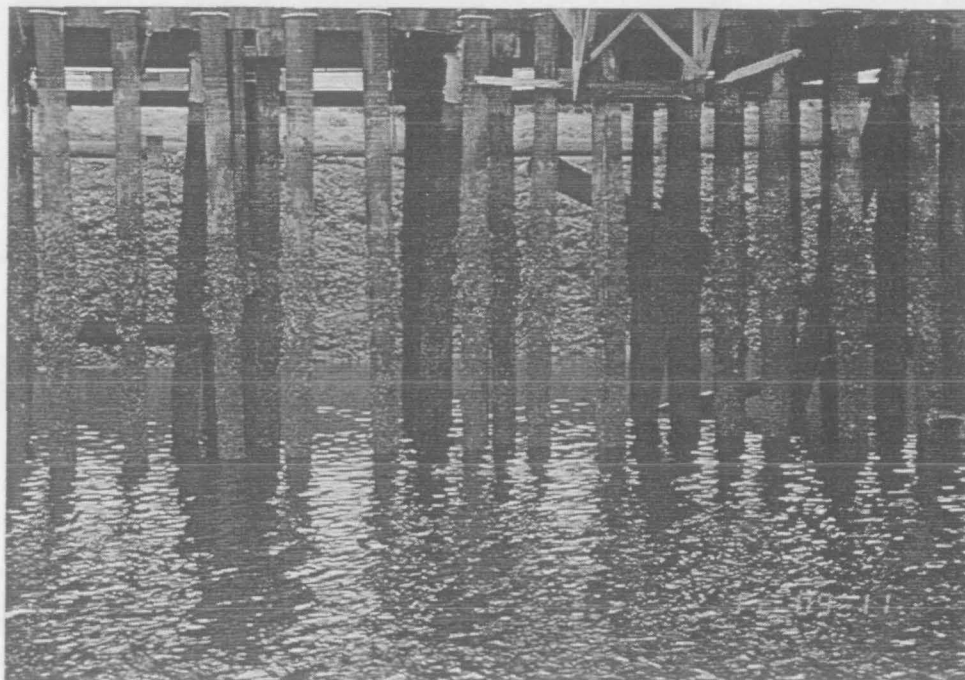
Photo was taken at an estimated tidal height of -1.4 feet

The sampling area extends across the face of the bank behind the USN Dock. The length of the composite area is approximately 750 feet. Four drains and one outfall pipe are listed on the TPCHD map as being in the composite area (TPCHD No. 81, 82). The bank consists of concrete rubble and blocks. Based on available studies, problem chemicals suspected to be associated with stormwater draining off of the paved truck yard at this site include: copper, lead, and zinc (Mercuri 1992a). Past industrial practices at the site include petroleum product storage by General Petroleum, Lillyblad Petroleum, U.S. Air Force, and U.S. Navy.

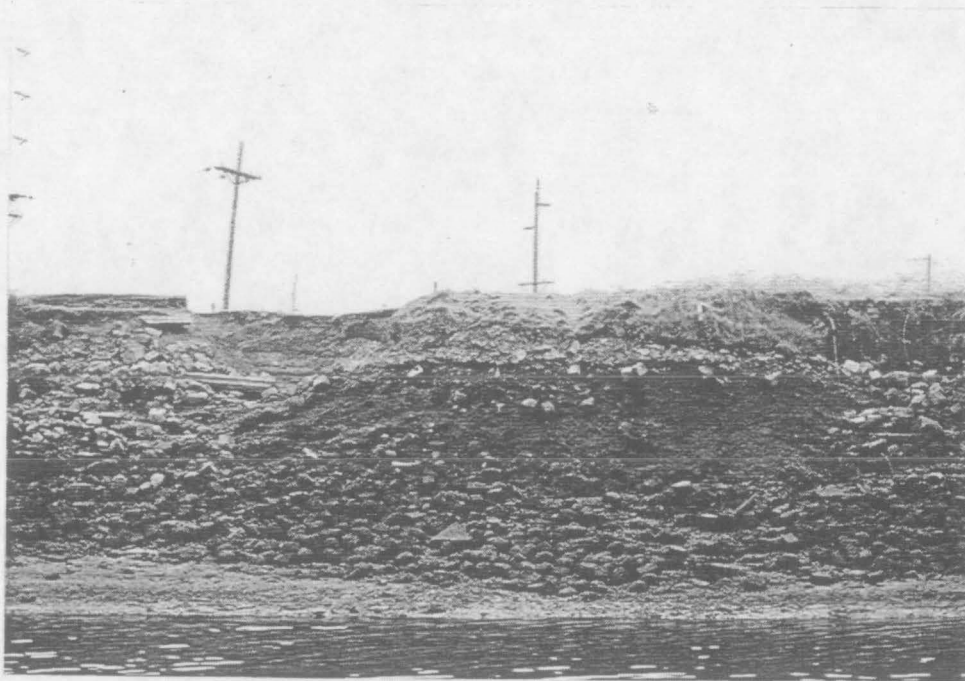
Photo was taken at an estimated tidal height of -1.5 feet

The sampling area extends across the face of the bank. The length of the composite area is approximately 425 feet. Two outfall pipes are mapped in the sampling area (TPCHD No. 79, 80). The bank has been rip rapped with concrete rubble and blocks. Based on available studies, problem chemicals which are suspected to be associated with this site include: PCB's, ethylbenzene, copper, lead, and zinc (Ecology 1992a).

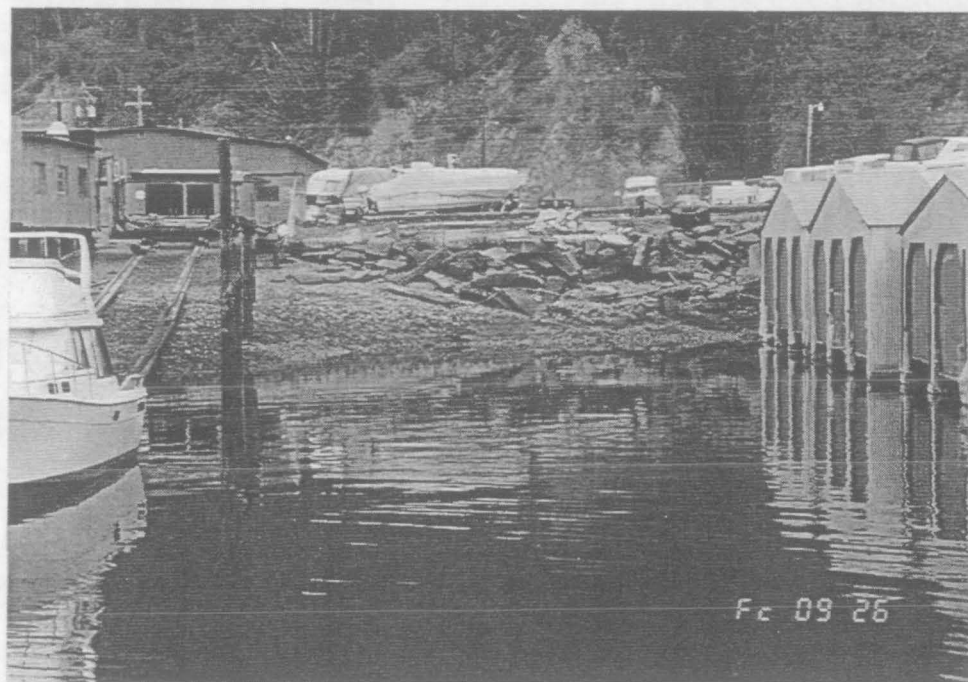
Photo was taken at an estimated tidal height of -0.2 foot

The sampling area extends across the face of the marina excluding a small sandy beach at the west end of the property in front of the Commencement Bay Marina. The length of the composite area is approximately 875 feet. Two outfall pipes are listed on the TPCHD map as being at the east end of the composite area (TPCHD No. 1). The top portion of the bank consists of concrete blocks and rubble with sand at the toe of the slope. Based on available studies, problem chemicals suspected to be associated with this site include: arsenic, copper, and zinc (Herold 1992a).

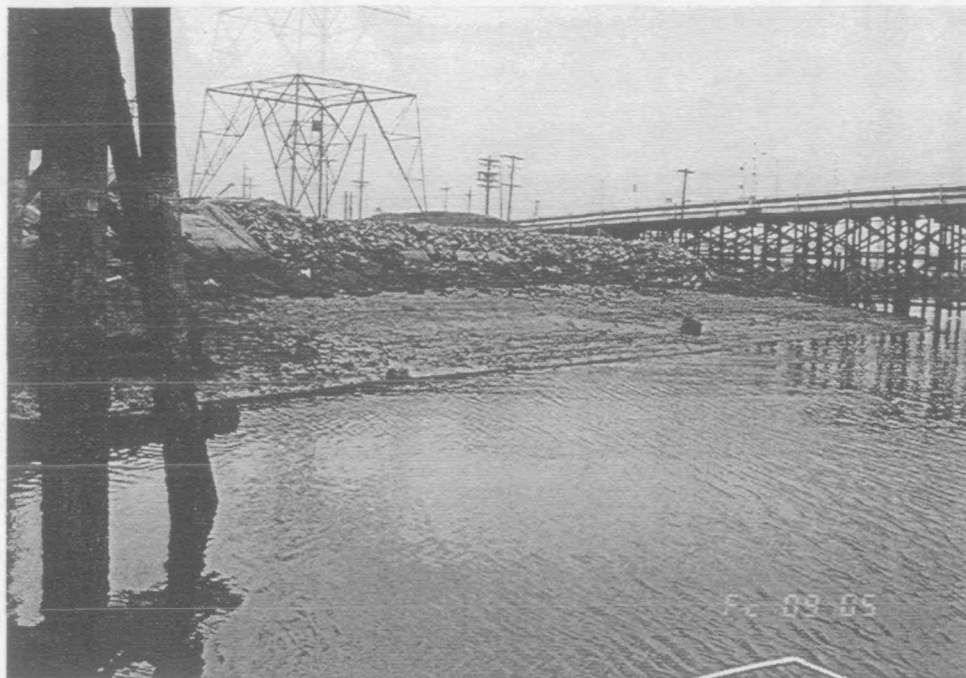
Sample Area 4201I W. of the City of Tacoma Steam Plant Plate 15

Photo was taken at an estimated tidal height of -1.5 feet

The sampling area extends from the western edge of the Tacoma Steam Plant to under the 11th Street Bridge. The length of the composite area is approximately 425 feet. There are three outfalls listed on the TPCHD map as being in the composite area (TPCHD No. 76, 78, 794). Outfall numbers 78 and 794 drain the roadway at the 11th Street Bridge. The top of the bank has been rip rapped with concrete blocks and other debris and the bottom of the bank leads to a broad mud and sand flat.

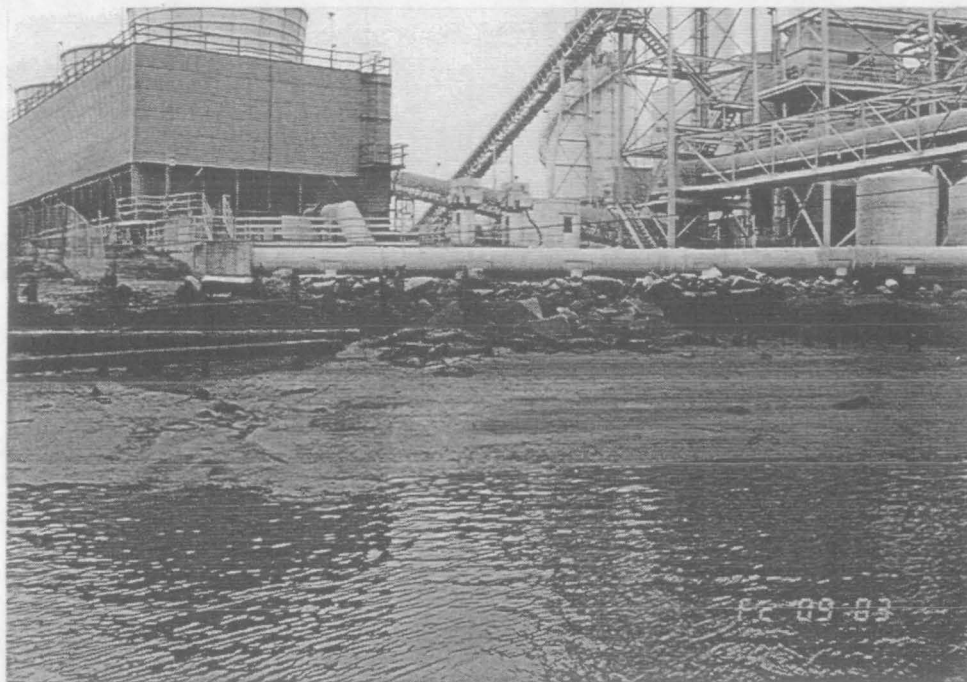
Photo was taken at an estimated tidal height of -1.4 feet

The sampling area extends from the eastern property line to the concrete bulkhead directly in front of the plant. The length of the composite area is approximately 275 feet. There are two outfall pipes listed on the TPCHD map as being in the sampling area (TPCHD No. 75). The bank at the top of the eastern edge of the sampling area is rip rapped with large concrete blocks, while the toe of the bank is a large sand flat. The western edge of the sampling area is at the base of the concrete bulkhead and will need to be sampled at a minus tide. One soil sample collected and analyzed by Ecology in 1991 contained elevated levels of arsenic and mercury above sediment quality objectives (Gooding and White 1991). Historically, several waste streams were generated at the plant that included PCB's and PAH's. The steam plant has been in operation since 1923.

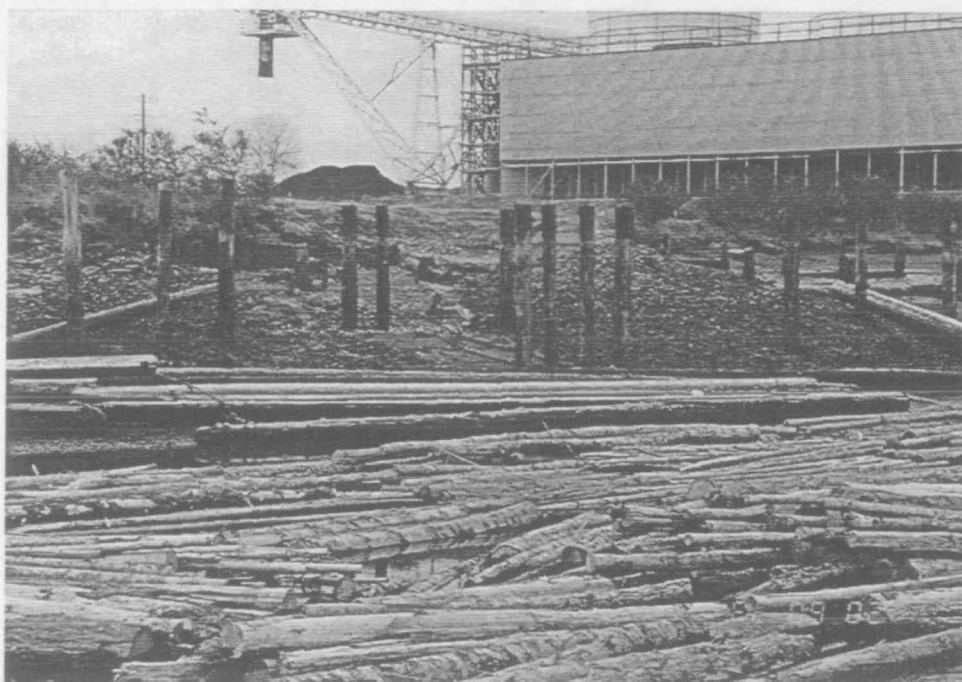
Photo was taken at an estimated tidal height of -1.4 feet

The sampling area is located along the western half of the Taylor Way Properties across an area where a large number of bricks were dumped over the bank. The length of the composite area is approximately 250 feet. The upper bank consists of small sized concrete debris and crumbling old pier and bulkhead supports. The lower portion of the bank consists of tidally flooded, coarse sandy material, which is covered with log rafts. Between the log rafts blue/black clay was seen where it had been scoured by the rafts. Log rafts permitting, sampling will be conducted on the toe of the bank in the sand flat. Sampling by Ecology in the intertidal in 1991 in the mid and western portions of the property found PCB's, arsenic, copper and lead (Ecology 1992b). Historically the site has been used by the pulp and paper industry (i.e. Shaffer Box and Pulp companies, ITT Rayonier) and by the chemical processing industry (Tacoma Powdered Metals, Burlington Environmental)

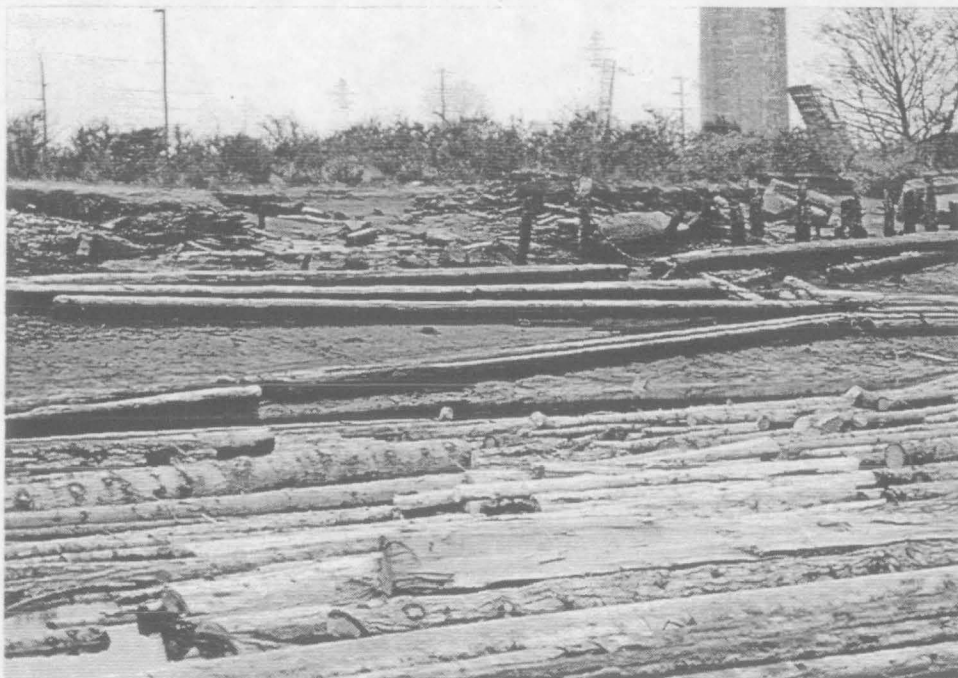
Photo was taken at an estimated tidal height of -1.4 feet

The sampling area is located in the mid section of the Taylor Way Properties. The length of the composite area is approximately 425 feet. The top of the bank is littered with concrete debris, and crumbling pier and bulkhead supports. The lower bank contains coarse sandy material over what appears to be blue/gray clay. Extensive log rafts cluttered the area where sampling will be conducted. Ecology intertidal sampling in 1991 in the mid and western portions of the property found PCB's, arsenic, copper, and lead (Ecology 1992b). Historically the site has been used by the pulp and paper industry (i.e. Shaffer Box and Pulp companies, ITT Rayonier) and by the chemical processing industry (Tacoma Powdered Metals, Burlington Environmental).

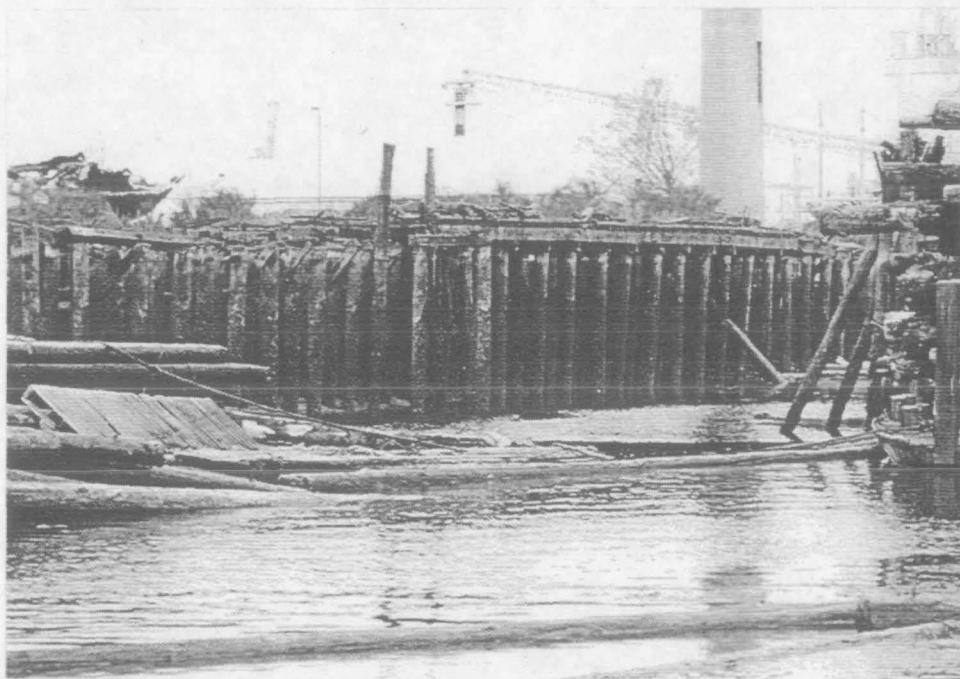
Photo was taken at an estimated tidal height of -1.3 feet

The sampling area is located behind the decaying dock at the east end of the Taylor Way Properties. The length of the composite area is approximately 400 feet. There is a ditch outfall along the east end of the property mapped by the TPCHD (No. 74). There is a wood bulkhead behind the dock and the shoreline behind it is crumbling leaving a space between the bulkhead and the actual shore. Ecology conducted intertidal sampling in 1991 in the mid and western portions of the property and found PCB's, arsenic, copper and lead (Ecology 1992b). Historically the site has been used by the pulp and paper industry (i.e. Shaffer Box and Pulp companies, ITT Rayonier) and by the chemical processing industry (Tacoma Powdered Metals, Burlington Environmental).

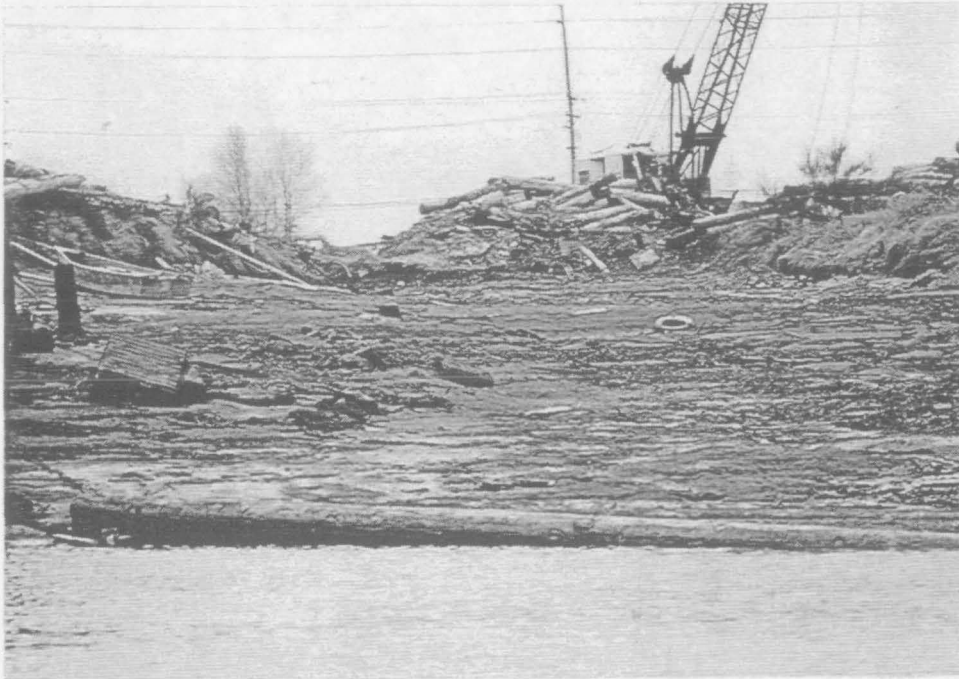
Photo was taken at an estimated tidal height of -1.2 feet

The sampling area is the entire embayment surrounding the open channel ditch (TPCHD No. 73). The length of the composite area is approximately 300 feet. In addition to the open channel ditch (TPCHD No. 73) there are three drain pipes listed on the TPCHD map as being in the composite area (TPCHD No. 72). The bank and shoreline are littered with cables and other metal debris. Ecology noted piles of what appeared to be shop floor sweepings or welding slag on the shore. Based on available studies, problem chemicals suspected to be associated with this site include: arsenic, copper, lead, and zinc (Herold 1992b). The site was previously used by Rail and Locomotive Co. as a yard for dismantling railroad cars.

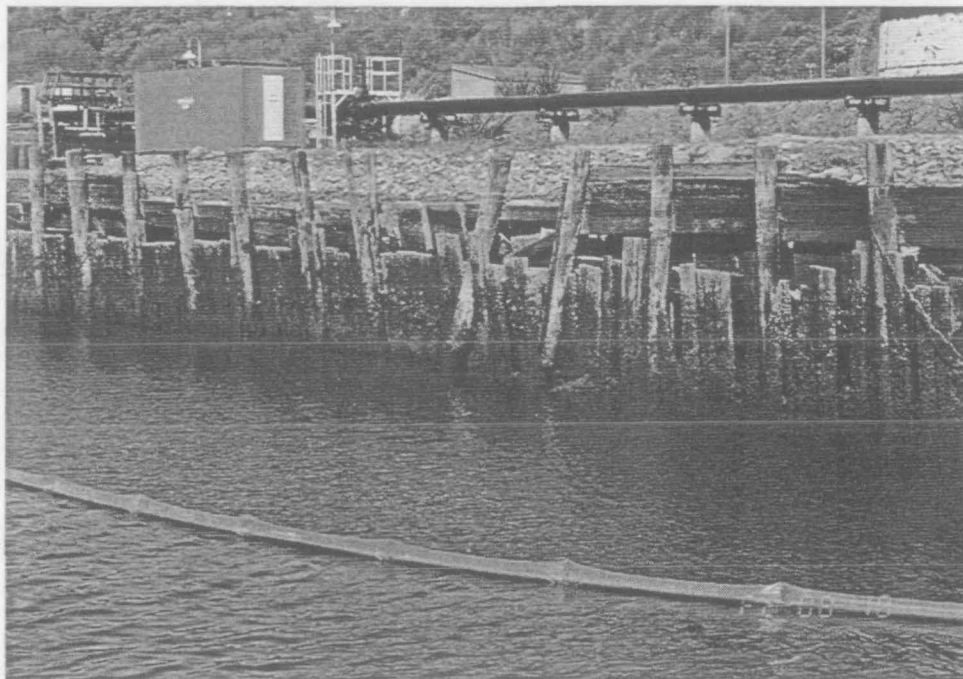
Photo was taken at an estimated tidal height of 0.2 foot

The sampling area extends from the point at the west end of the property to the mid portion of the bulkhead at Sound Refining. The length of the composite area is approximately 400 feet. There are six outfall pipes listed on the TPCHD map as being in the composite area (TPCHD No. 15, 16, 17, and 704). Sound Refining Inc. has an Individual NPDES permit to discharge treated process wastewater and stormwater into the waterway. The bank is shored with a wooden bulkhead that is crumbling in many places. The lower bank could not be observed during the reconnaissance survey due to the tide level. Problem chemicals found near the NPDES permitted outfall during monitoring included: hexachlorobenzene, benzyl alcohol, phenol, PCB's, arsenic, copper, and zinc (Parametrix 1992).

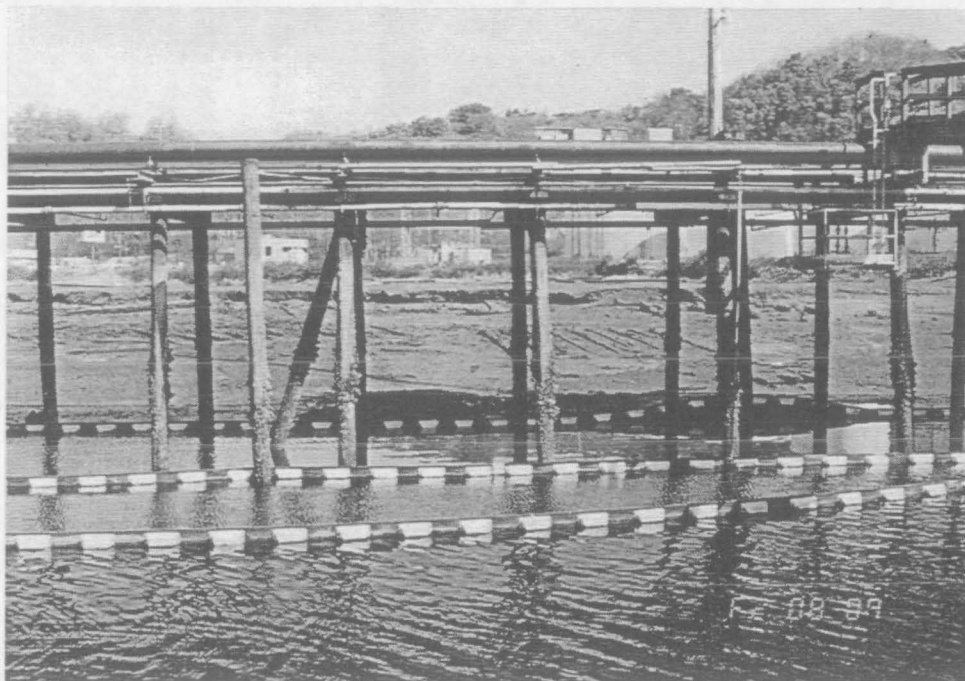
Photo was taken at an estimated tidal height of 0.4 foot

The sampling area extends along the bank adjacent to the broad tideflat at the west end of the property. The length of the composite area is approximately 400 feet. Sound Refining Inc. has an Individual NPDES permit to discharge treated process wastewater and stormwater into the waterway. The bank is low and drops rapidly into a long, low sloping mud and sand flat. The intertidal area below the bank is littered with wood and metal debris. Based on available studies, problem chemicals which are suspected to be associated with this site include: hexachlorobenzene, benzyl alcohol, phenol, PCB's, arsenic, copper, and zinc (Parametrix 1992).

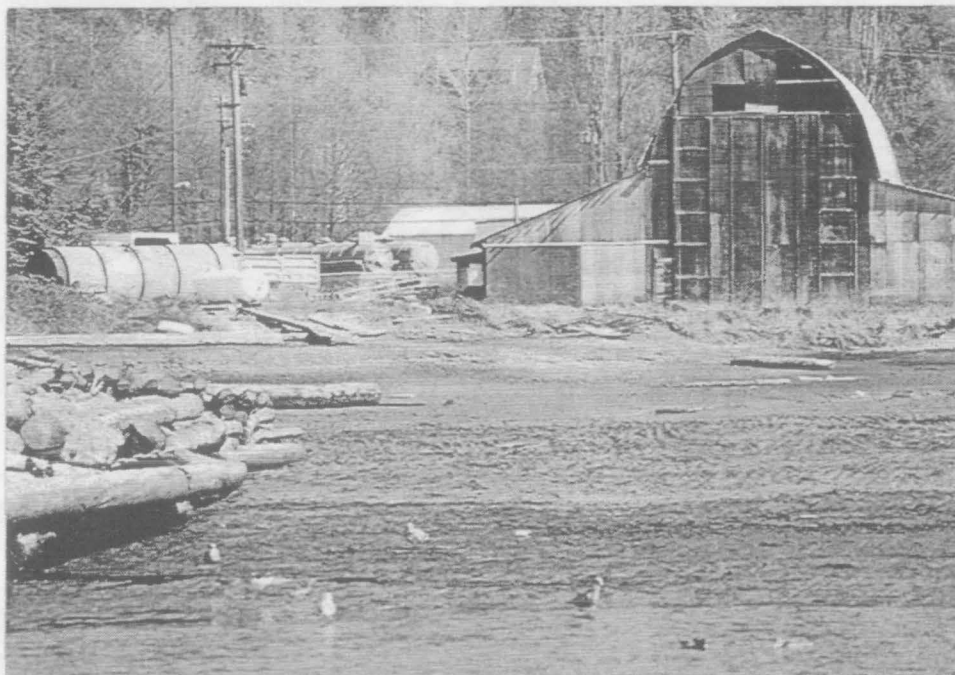
Photo was taken at an estimated tidal height of 0.4 foot

The sampling area is located in the high intertidal zone off of site of the former Bay Chemical Co. (currently Airo Services) and Banyan Rail Services and adjacent to 11th street bridge. The length of the sample composite area is approximately 250 feet. There are three outfall pipes listed as being in the composite area (TPCHD No. 10,11,and 735). The bank is low and drops rapidly into a long, low sloping mud and sand flat. Based on available studies problem chemicals associated with the site include: arsenic, copper, lead, nickel and zinc (Ecology 1992a).

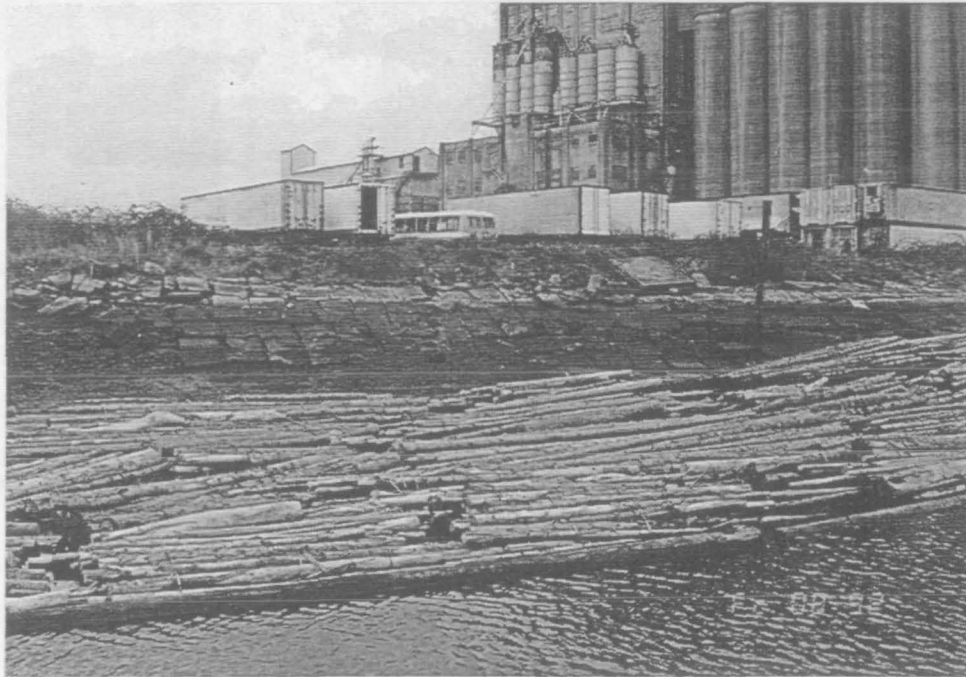
Photo was taken at an estimated tidal height of -1.0 foot

The sampling area is located at the toe of the slope across the front of the property. The length of the composite area is approximately 350 feet. There are two outfall pipes listed on the TPCHD map as being at the top of the bank above the composite area. The bank consists of large flat concrete blocks with some metal debris on them. Three releases of problem chemicals were reported in the past including PAH's, copper, lead, and zinc (Gooding 1990a, Crosby & Overton, 1988). The lower portion of the bank is covered with log rafts, but where visible, sediments appeared to be sand and mud.

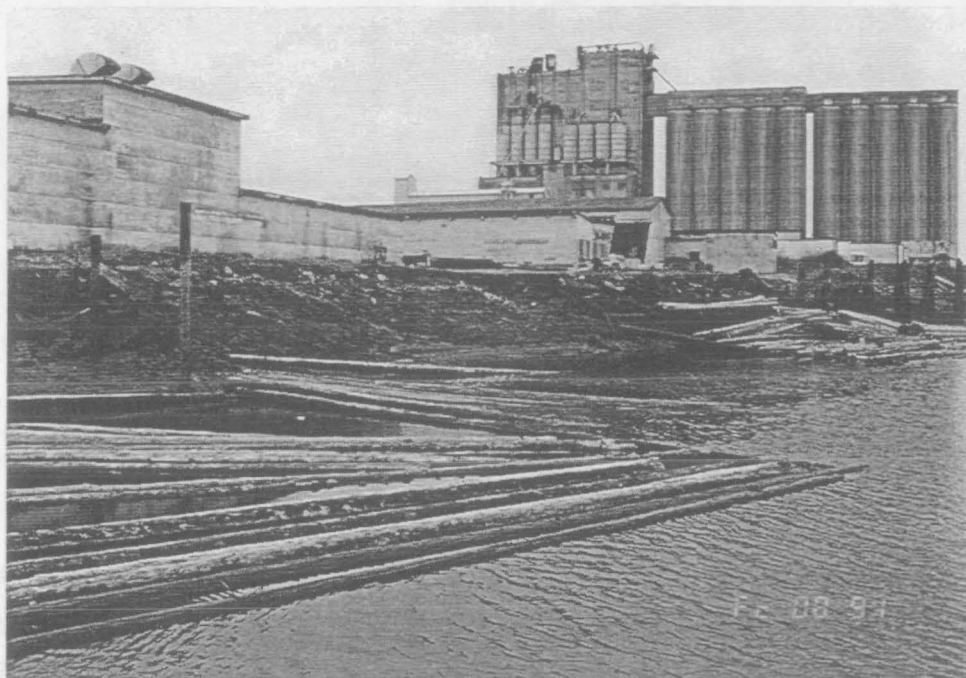
**Plate 26**

Photo was taken at an estimated tidal height of -1.0 foot.

The sampling area is located at the western edge of the property adjacent to Cenex. The length of the composite area is approximately 350 feet. Two outfall pipes, and a drainage ditch are listed on the TPCHD map as being in the composite area (TPCHD No. 71). Buffelen Woodworking Co. has a General NPDES permit for the discharge of stormwater runoff to the waterway. The bank consists of broken concrete debris, rock and old dock pilings. The bulkhead at the top of the bank is being undercut and is crumbling into the intertidal area. The lower intertidal area is scoured by log rafts and the material between the rafts appears to be sand overlaying blue/gray clay. Based on available studies, problem chemicals which are suspected to be associated with this site include: PCB's, formaldehyde, arsenic, copper, chromium, lead, mercury, nickel, and zinc (Buffelen 1988, Hart Crowser 1989). The Buffelen Woodworking Company or its predecessors have manufactured wood products at the site since 1910.

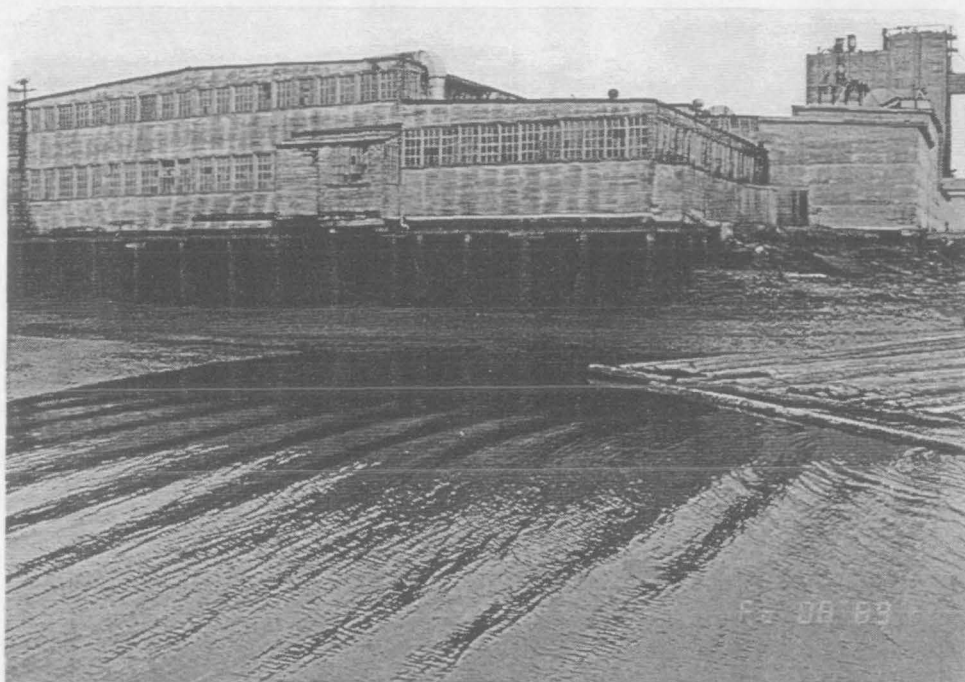
Photo was taken at an estimated tidal height of -0.9 foot

The sampling area is located on the western side of the small embayment (Hylebos Inlet) overhung by a portion of the old veneer factory. The length of the composite area is approximately 300 feet. There are two outfall pipes listed on the TPCHD map that drain onto the composite area (TPCHD No. 70). Buffelen Woodworking Co. has a General NPDES permit for the discharge of stormwater runoff to the waterway. The intertidal area below the bank consists of coarse sand, gravel, and mud. Based on available studies, problem chemicals which are suspected to be associated with this portion of the site include: PCB's, formaldehyde, arsenic, copper, chromium, lead, mercury, nickel, and zinc (Buffelen 1988, Hart Crowser 1989). The Buffelen Woodworking Company or its predecessors have manufactured wood products at the site since 1910.

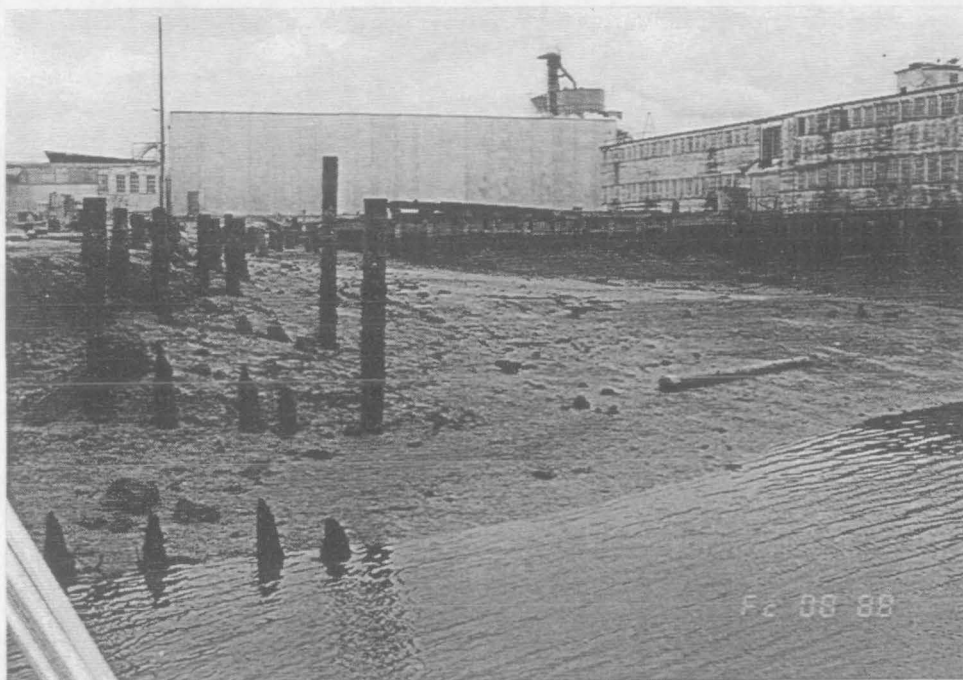
Photo was taken at an estimated tidal height of -0.9 foot

The sampling area is adjacent to the pentachlorophenol (PCP) cleanup area at the east side of Hylebos Inlet. The length of the composite area is approximately 300 feet. There is one outfall pipe listed on the TPCHD map that drain adjacent to the west side of the composite area. Buffelen Woodworking Co. has a General NPDES permit for the discharge of stormwater runoff to the waterway. The bank and surrounding intertidal area are full of decaying pier pilings and log debris. There is a wide shallow ditch that drains the PCP cleanup area. The PCP area is slated to be capped. Based on available studies, problem chemicals which are suspected to be associated with this portion of the site include: PCP, PCB's, formaldehyde, arsenic, copper, chromium, lead, mercury, nickel, and zinc (Buffelen 1988, Hart Crowser 1989). The Buffelen Woodworking Company or its predecessors have manufactured wood products at the site since 1910.

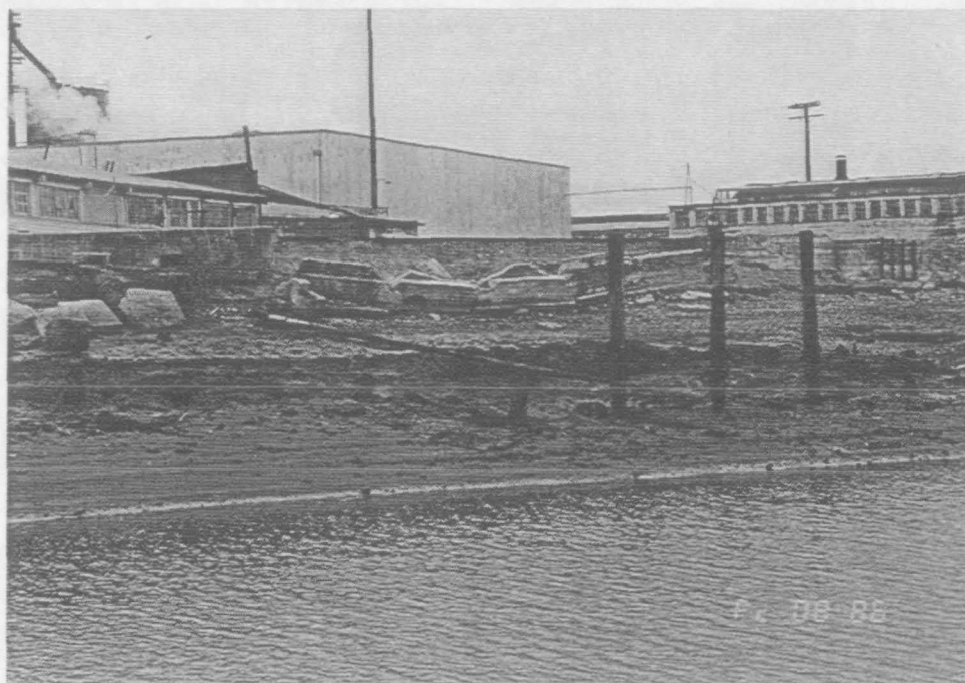
Photo was taken at an estimated tidal height of -0.8 foot

The sampling area extends from the PCP cleanup area east to the Lincoln Street right-of-way. The length of the composite area is approximately 225 feet. There is one outfall pipe in the composite area listed on the TPCHD map (TPCHD No. 68). Buffelen Woodworking Co. has a General NPDES permit for the discharge of stormwater runoff to the waterway. The bank is being undercut in this area by erosion and the upper intertidal area consists of asphalt and concrete rubble from the broken bulkhead and parking lot. Buffelen received a shoreline permit to stabilize the bank along this portion of the property. Based on available studies, problem chemicals which are suspected to be associated with this portion of the site include: PCP, PCB's, formaldehyde, arsenic, copper, chromium, lead, mercury, nickel, and zinc (Buffelen 1988, Hart Crowser 1989). The Buffelen Woodworking Company or its predecessors have manufactured wood products at the site since 1910.

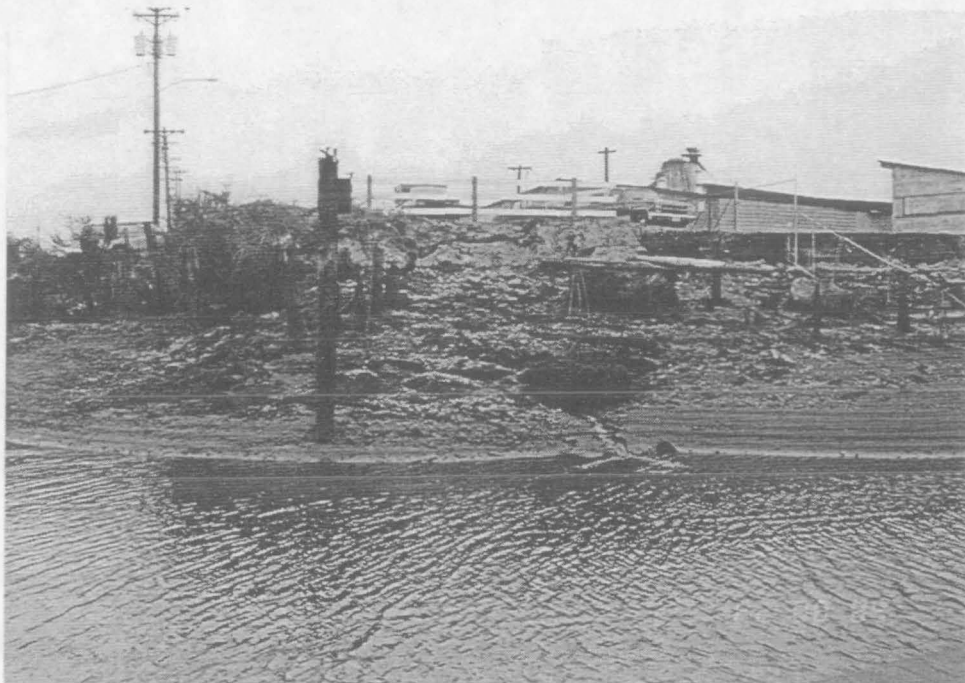
Photo was taken at an estimated tidal height of 0.4 foot

The sampling area is located in the intertidal embayment off the end of Lincoln Street. The length of the sample composite area is approximately 240 feet. A large storm drain from Lincoln Street (TPCHD No. 66) discharges to the western end of the composite area. The bank consists of broken concrete rubble, rip rap material, and the remains of concrete pilings. Based on available studies problem chemicals associated with adjacent sites include: pentachlorophenol, PCB's, arsenic, copper, lead, and zinc (Tetra Tech 1985).
